Duck Creek Watershed Management Plan

Final Report

February 2008

Williams Creek Consulting, Inc.
Babeca Building
919 North East Street
Indianapolis, IN 46202
(317) 423-0690

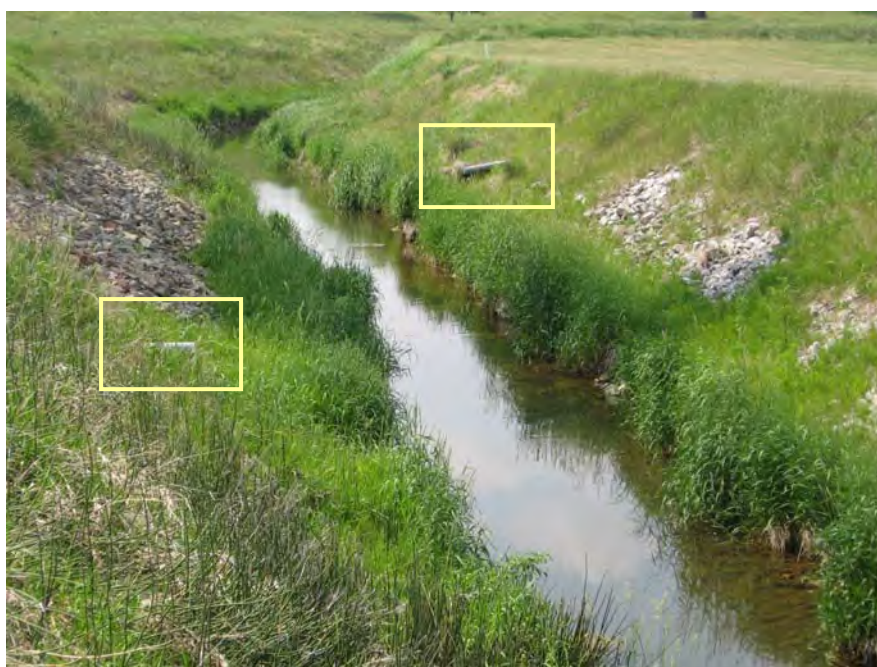
Figure 29. Tile Drains in the Duck Creek Watershed

Tile drains have been determined to affect water quality in many parts of Indiana. Newer tile drains usually consist of perforated, flexible tubes, while older tile drains are commonly clay tile. Information on the number and location of tile drain systems in Indiana is not available, but agricultural experts expect that nearly all poorly drained farmland contain tile drain systems (Schnoebelen et al., in press). Based on the majority of poorly drained soils and the heavy emphasis on agriculture in the Duck Creek Watershed, it can be assumed that most of the land in the watershed outside of Elwood is artificially drained. Tile drains short circuit infiltration into the soil and bypass riparian buffers, therefore transporting nutrient laden water directly to nearby ditches or streams. Tile drains can be particularly problematic to water quality if rainfall occurs shortly after the application of fertilizers or manure. Studies are being conducted that may link the hypoxic zone or “dead zone” in the Gulf of Mexico to high nitrogen loads from agricultural drainage in the Midwest to the Mississippi River. Numerous studies, including a Purdue University study, *Interpreting Nitrate Concentration in Tile Drainage Water*, have found high nitrogen concentrations in tile drains, and determined that agricultural fertilizers, manure application, conventional tillage, crop rotation, and the spacing of the tile drains all influence the amount of nitrogen entering tile drains (Bongen et al.). **Figure 29** displays two tile drains outletting into a drain in the Duck Creek Watershed.

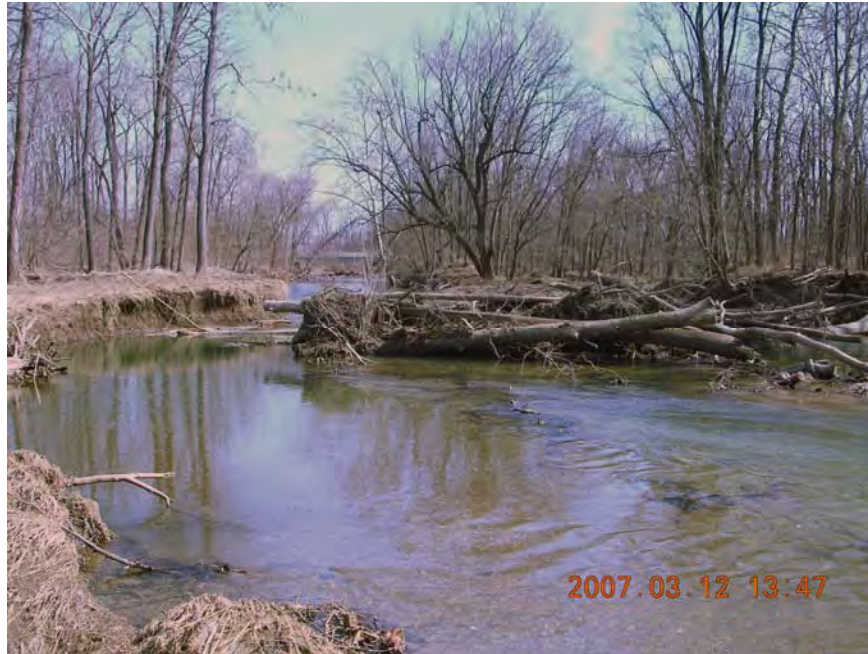
Figure 46. Log Jam and Erosion on SR 213 in the Long Branch Watershed (W1)

Stream bank erosion is occurring in several areas throughout the watershed. The erosion is more severe in the southern portion of the Lamberson Ditch Watershed along both Duck Creek and Lamberson Ditch, where large log jams are located. Typical areas of stream bank erosion range from 40 to 200 feet in length and 8 to 30 feet in height. (See **Figure 37** for location of known log jams.) **Figure 46** shows streambank erosion caused by a log jam in the Long Branch watershed (W1). **Figure 47** shows a less severe case of streambank erosion in the Lamberson Ditch watershed (W3).
