Landuse

Septic Suitability Map

Upper White River Watershed Alliance
P.O. Box 2065
Indianapolis, Indiana 46206

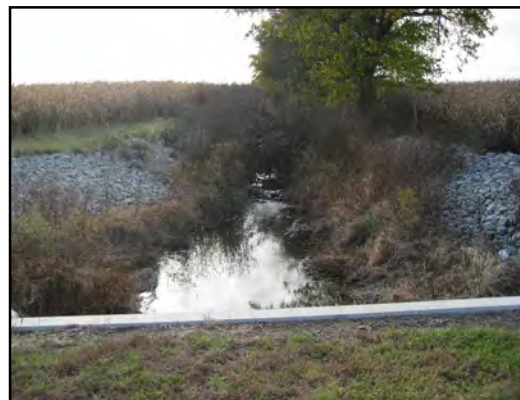
Example of Rip-Rap Stabilized Streambank

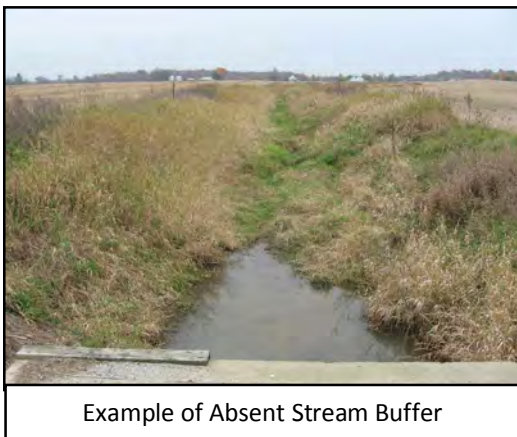
Example of Absent Stream Buffer

Stream buffers are areas of natural vegetation between a surface water body and the surrounding land use. Buffers were only identified as adequate if they were at least ten feet in width. As shown on the example picture, Absent Buffers are those where the agricultural land or development is farmed/built up to the top of the stream bank leaving no possibility of runoff from being filtered through a grassed or treed area before entering the stream. Runoff from the surrounding land may carry sediment and organic matter, and plant nutrients and pesticides that are

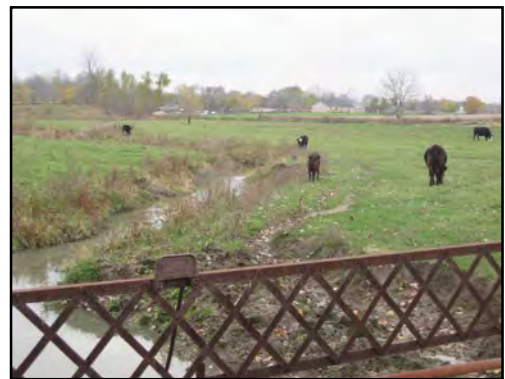
In-stream debris was also noted during the windshield survey. In-stream debris can inhibit wildlife and aquatic habitat, increase flooding risks, and introduce additional pollutants. This information is valuable for the purposes of determining public education opportunities. Debris was assessed on a subwatershed scale based on the presence and type of debris (trash, deposits, log jam, etc) identified during the windshield survey. Animal access was assessed on a subwatershed scale based on the presence of animals or indicators of access.

Example of Animal Access to Stream
